INPO 11-005
November 2011

Special Report on the Nuclear Accident at the Fukushima Daiichi Nuclear Power Station

Revision 0

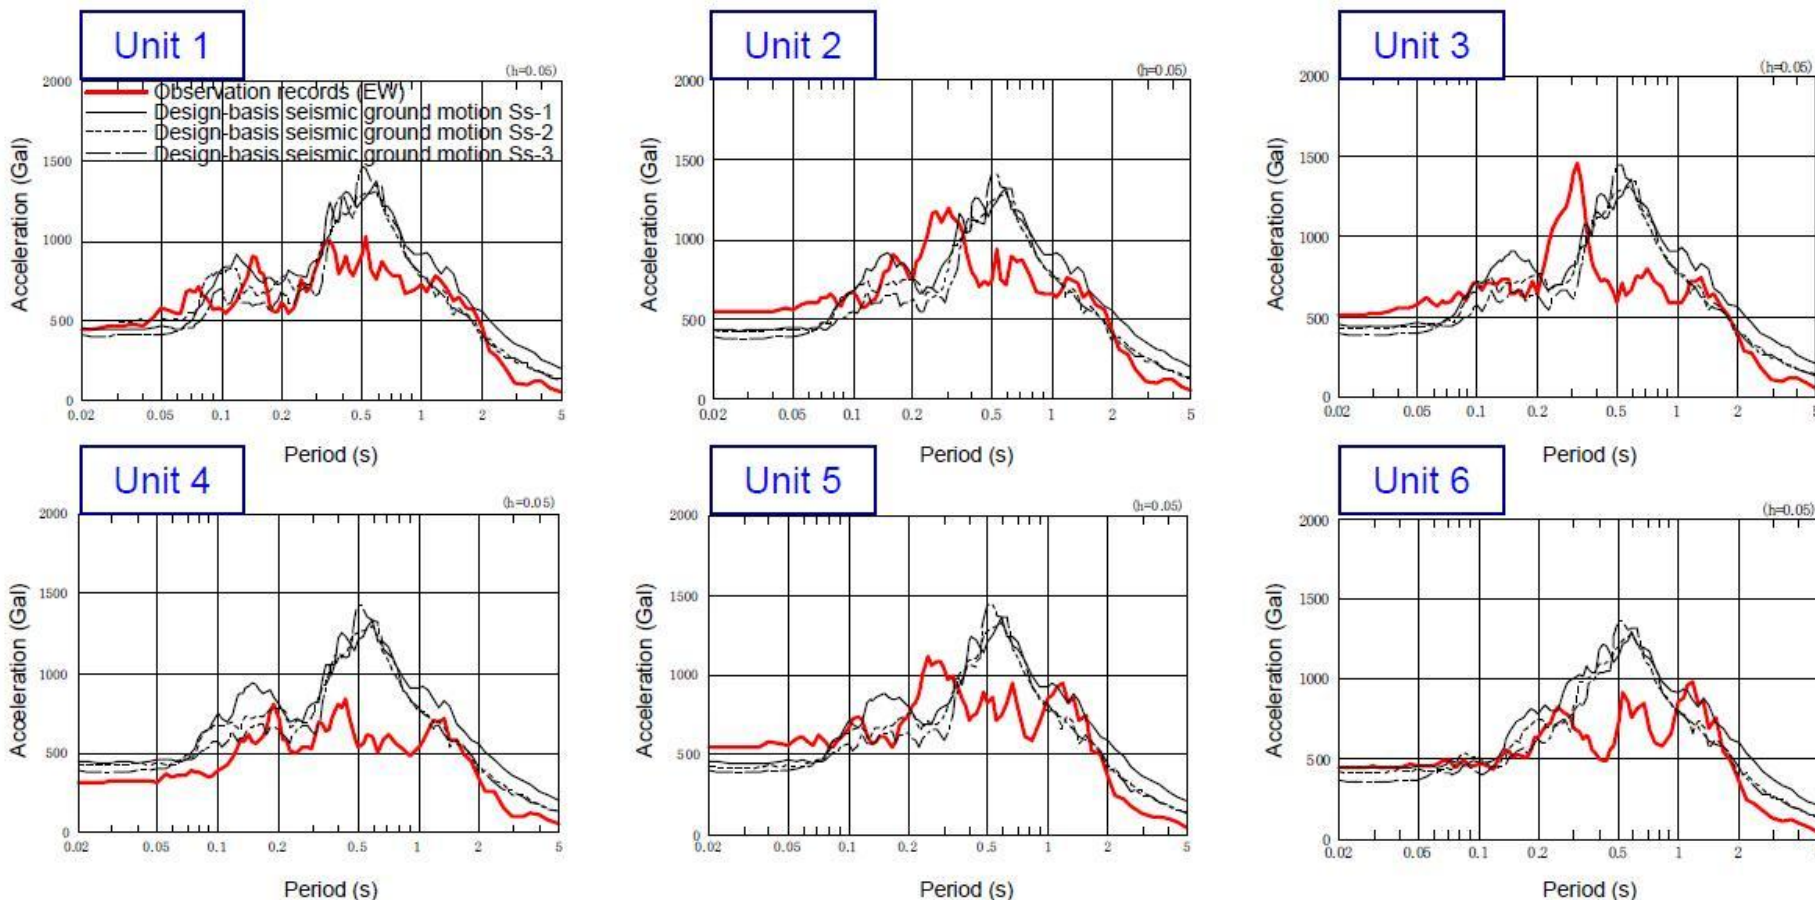
Figure 7.1-1 Preliminary Seismic Data

While no formal seismic walkdowns have been performed, a review of plant indications and operator logs does not indicate any seismic damage that affected the operator response to the earthquake. Before the tsunami, all emergency diesel generators that were operable started and loaded as expected, and each emergency core cooling system the operators used appeared to function as designed. Reactor pressure, reactor water level, and containment pressure indications for units 1, 2, and 3 appeared as expected following a scram and did not indicate any potential breach of the reactor coolant system from the earthquake.

Graphs indicate the observed values as compared to the design basis seismic criteria.

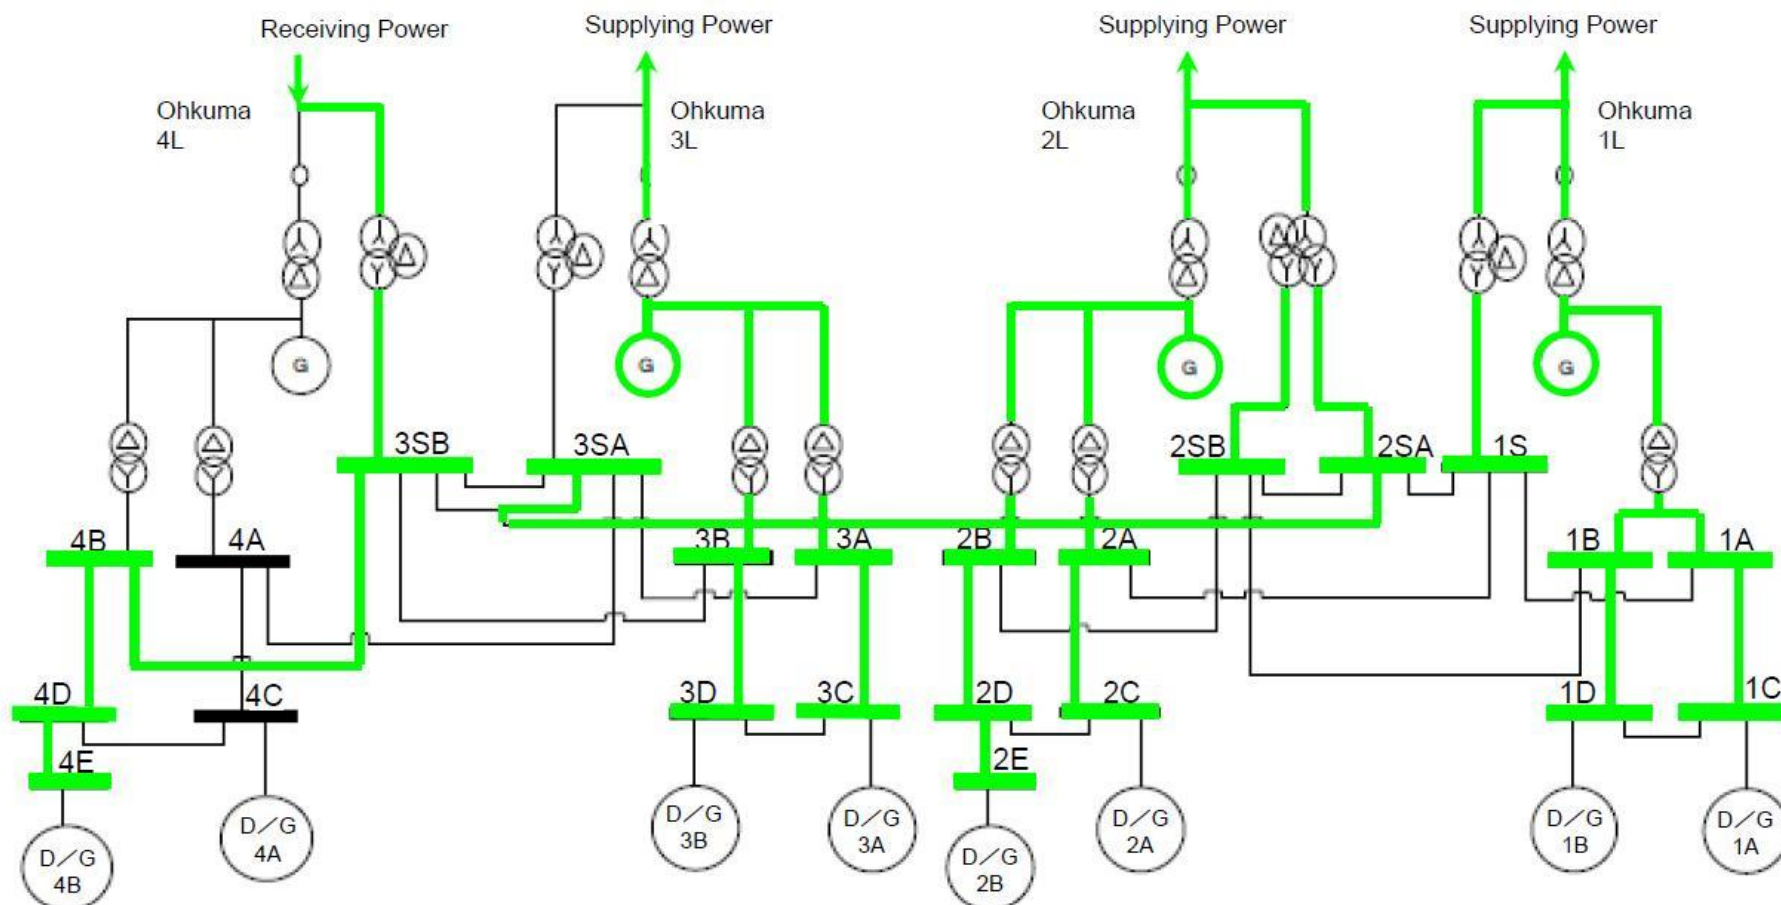
Figure 7.4-6 Simplified Electrical System¹¹

Systems highlighted in green were in service (energized). The 4A EDG and Unit 3 startup transformer were out of service for planned maintenance at the time of the event.
